# Alert Service Bulletin

## Alert Service Bulletin No. 229

### Magneto, Impulse Coupling, & Impulse Cam Inspection

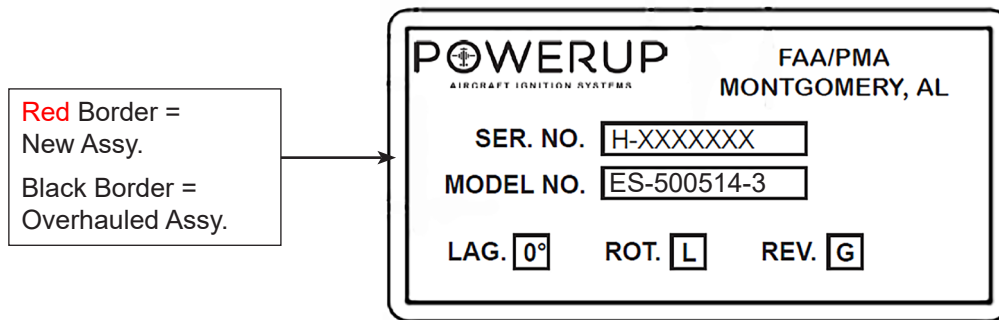
Figure 1 - PowerUp™ S-20 Data Tag

- (a) For Affected Model/Series Only:
    - 1) If the data tag **does** display HET's **PowerUp™** data, reference HET Manual PM6003 Rev. New or later FAA accepted revision for servicing information. See Fig. 1.

- 2) If the data tag does **not** display HET's **PowerUp™** data as shown in Fig. 1, reference the latest manufacturers maintenance manual for the magneto part number being serviced, e.g., Continental Aerospace Technologies.

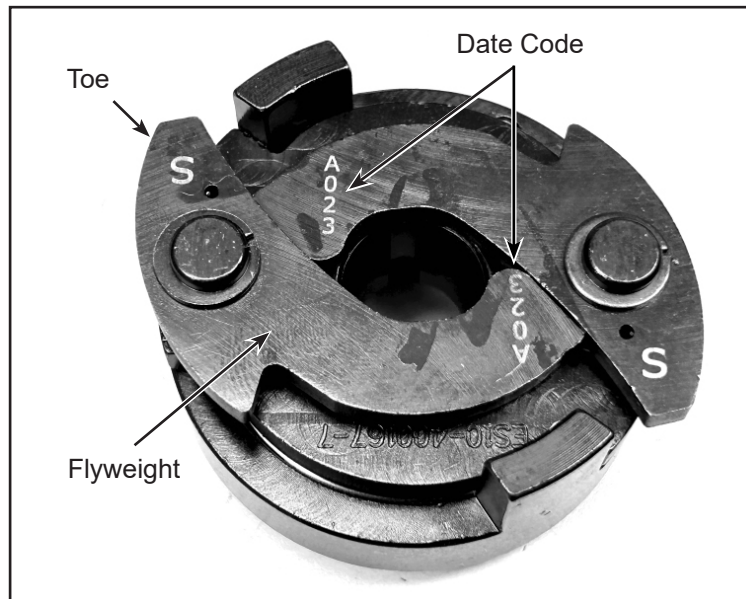
**Figure 2 - Impulse Cam Assembly Date Code**

- (c) Inspect the impulse cam assembly date code. See Fig. 2.
  - 1) If the cam assembly has less than 250 hours TIS and either flyweight date code **is** one of the following, the unit is affected. Refer to 3.C.(2) Impulse Coupling or Impulse Cam Replacement.

- 2) If either cam assembly flyweight date code **is** one of the following and the unit has 250 hours TIS or more, visually inspect flyweight for deformation damage, particularly at the toe.

Affected Date Codes: **A023 B023 E023**

It is possible for date codes on the two flyweights to be mismatched. If either date code matches an affected date code per para. 3.C.(1)(c), the impulse coupling assembly or impulse cam assembly must be replaced.

- a) If deformation is noted, Refer to 3.C.(2) Impulse Coupling or Impulse Cam Replacement.
    - b) If deformation is not noted, cam assembly may continue in service in accordance with the latest applicable maintenance manual requirements. Identify magneto and cam assembly per per Figures 3 and 4. Reassemble and install the impulse coupling in accordance with the latest applicable maintenance manuals. Continue to 3.D. Return to Service.

- (2) Impulse Coupling or Impulse Cam Replacement
- (a) Install a new impulse coupling or impulse cam assembly in accordance HET Manual P/N PM6003 Rev. New or later FAA approved revision.
  - (b) Mark the magneto assembly data-plate with a yellow paint mark (Fig. 3) .25 in. diameter as a visual indicator of compliance with this ASB.
  - (c) Install magneto(s) onto the engine in accordance with the latest engine/airframe service instructions or maintenance manual. Continue to 3.D., Return to Service.
