# SERVICE BULLETIN

**Service Bulletin No. 075 Rev. A**

## **Alternator Drive Coupling Inspection**

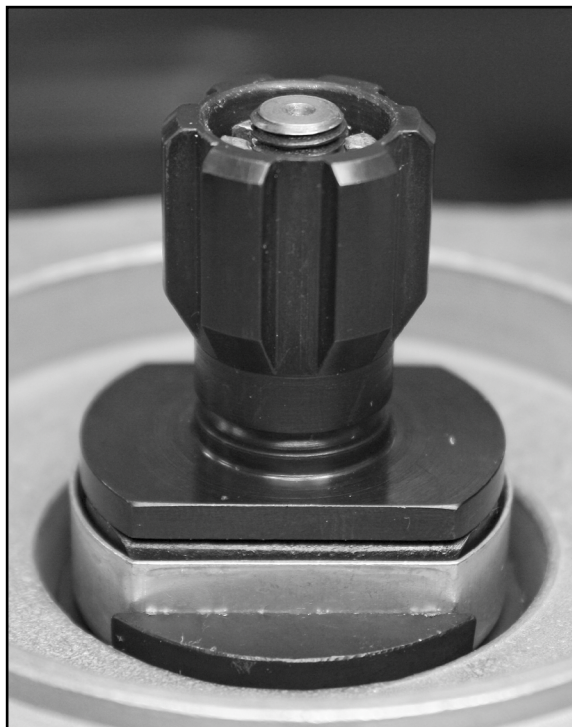
- (3) If the alternator serial number is affected per section 1.A:
  - (a) Utilize applicable aircraft maintenance manual to remove the alternator and inspect the alternator gear drive (Item Number 4, Table 2 – Materials Required) for correct alignment. Refer to Figures 1 & 2 - Alignment Inspection.

Figure 1 - **CORRECT** Alignment

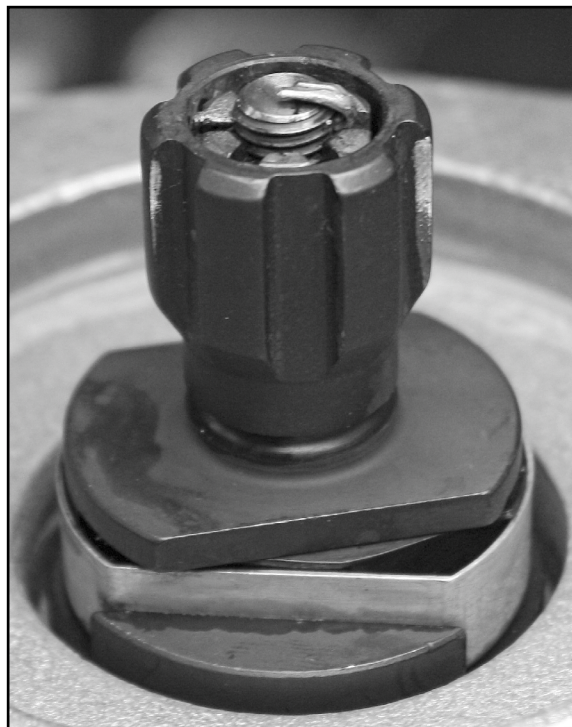
- (1) HET has discovered alternators containing part numbers listed in section 1.A of this SB contain a condition that has potential, if not corrected, to introduce foreign object debris (FOD) into the engine cavity.

Figure 2 - **INCORRECT** Alignment

- 1) If **INCORRECT** alternator gear drive alignment is observed, continue to Corrective Action section 3.B.(1).
    - 2) If **CORRECT** alignment is observed, the affected alternator may be re-installed on aircraft and re-inspected in accordance with section 3.A.(3) every fifty (50) hours time-in-service until a total of two hundred and fifty (250) hours time-in-service is reached from release date of this SB.
