# Service Bulletin

## Service Bulletin No. 068 Rev. 1

### **Jasco Alternator Wire Harness Wire Chafing Protection or Replacement**

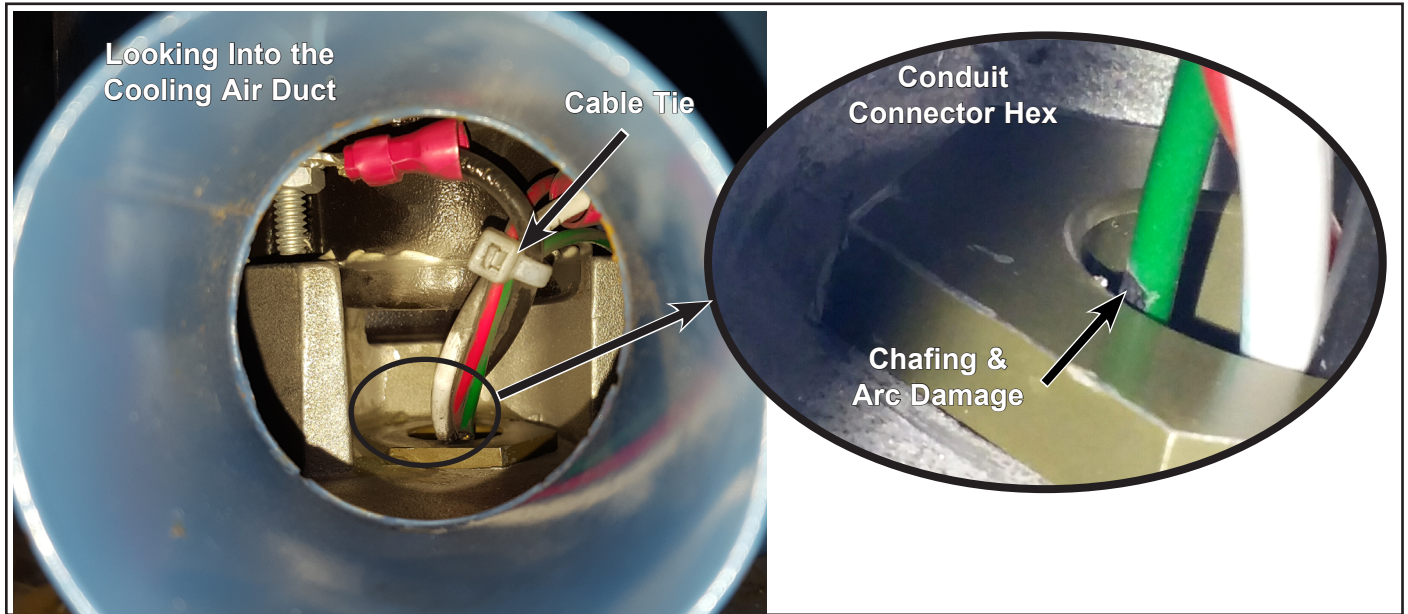
- (1) Jasco alternator models with serial numbers per the Effectivity above may experience a chafing condition of the electrical harness during normal operation.
- (2) A chafing condition of the electrical harness may result in electrical arcing, tripped circuit breaker, and loss of alternator function. Refer to Fig. 1.
- (3) Regulatory action is unknown.

Figure 1 - Wire Harness Chafing Condition

- (1) At the next regularly scheduled inspection or within twelve (12) months after the effective date of this Service Bulletin, whichever occurs first, in accordance with the Accomplishment Instructions of this Service Bulletin:
  - (a) install chafing protection on the electrical harness wires if the wires are not damaged or,
  - (b) install a new electrical wire harness if wires are damaged.

- (10) Wrap the spiral insulation over the four wires using a screw action, inserting it until the spiral insulation seats against the cable tie and passes the area of the conduit connector where chafing may occur.

- (a) Tighten the spiral insulation wrap to limit any gaps. Refer to Fig. 1 and Fig. 3.
- (11) Push the knurl collar with retained grommet along the wire harness to the conduit connector.

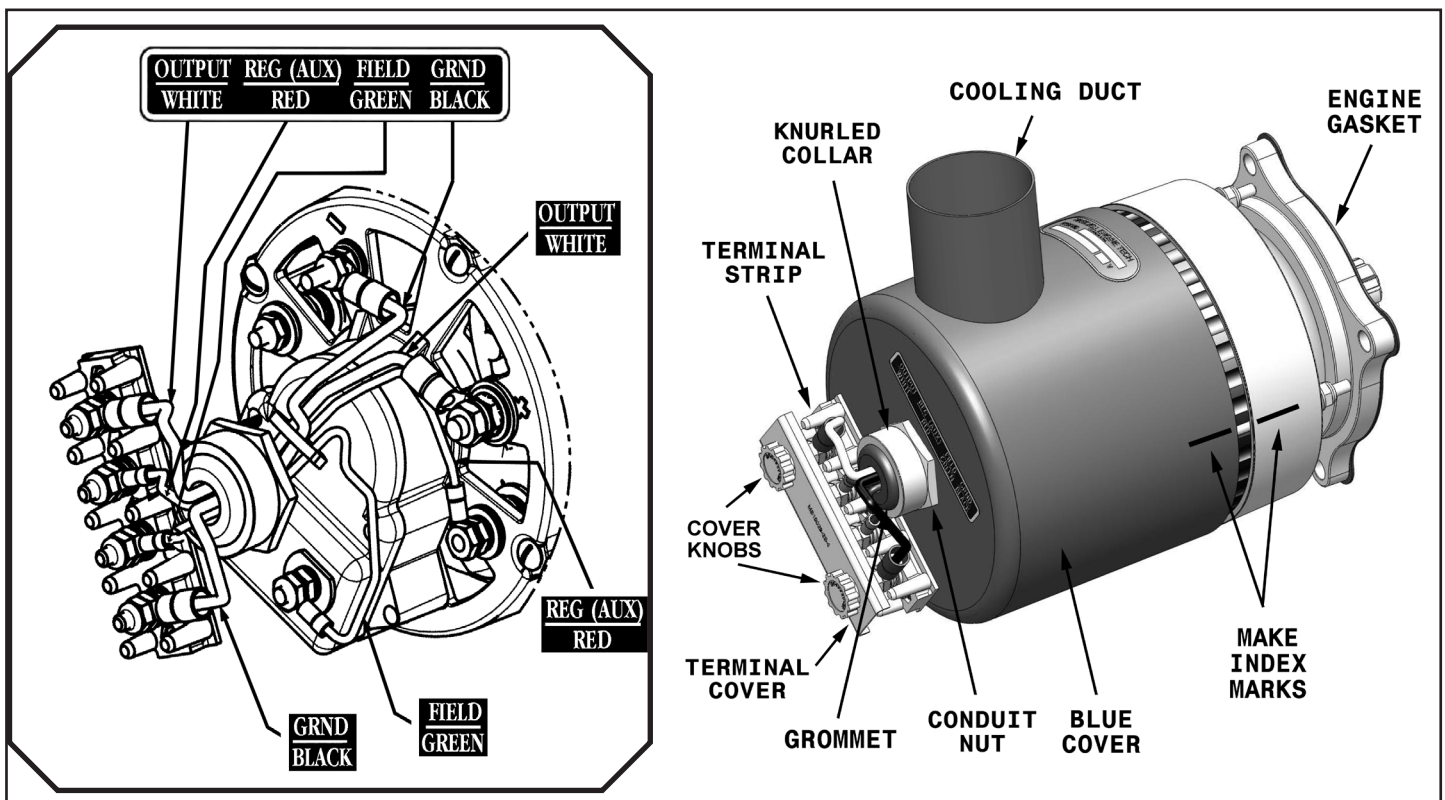
Figure 2 - Component Identification

- (a) The chafing protection is a two inch piece of .375 inch PTFE spiral insulation that must be wrapped around all four wires of the wire harness. Refer to Fig. 3.

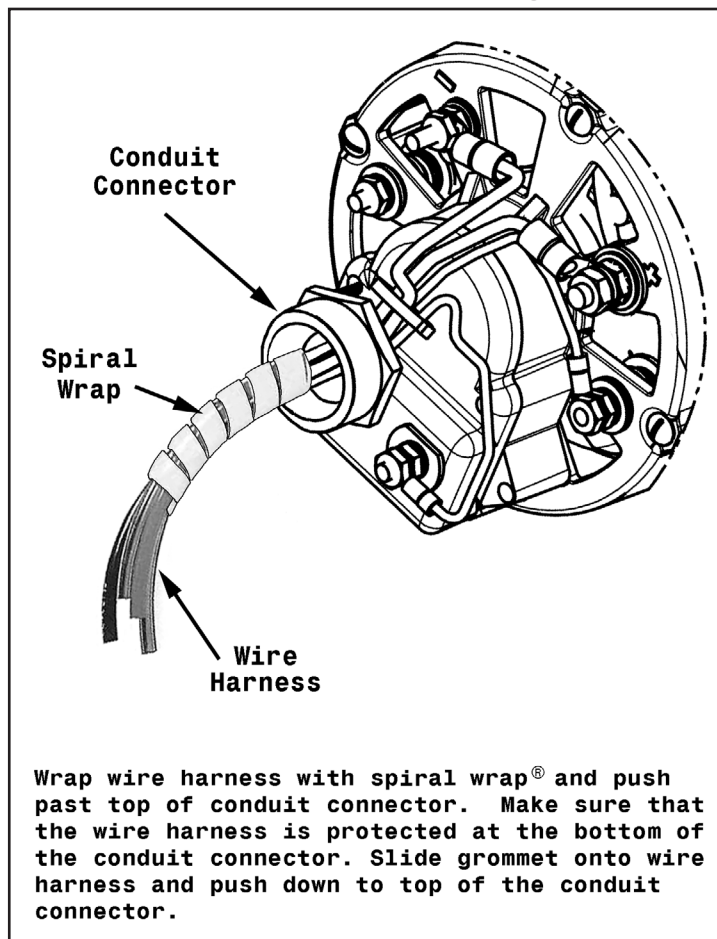
Figure 3 - Spiral Insulation Example

- (12) Thread the knurl collar onto the conduit connector.
  - (a) Tighten the knurl collar finger tight then 1/4 turn more. Refer to Fig. 4.
- (13) Install each wire on the terminal strip stud that corresponds to the color of the wire and the color listed on the placard above the terminal strip. Refer to Fig. 2.

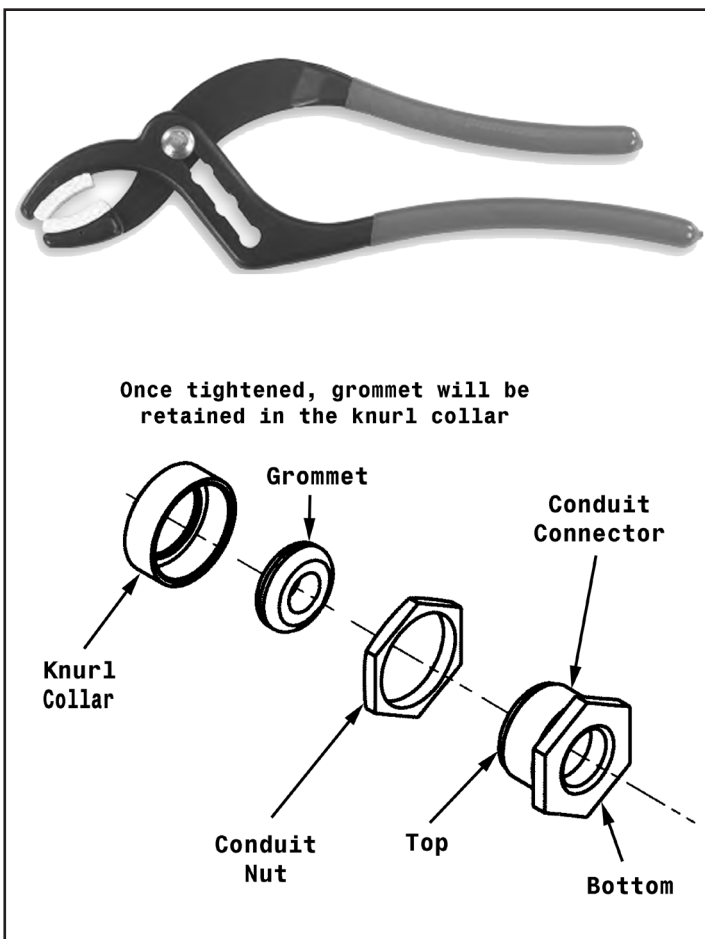
Figure 4 - Soft Jaw Connector Plier & Connector Stack Up

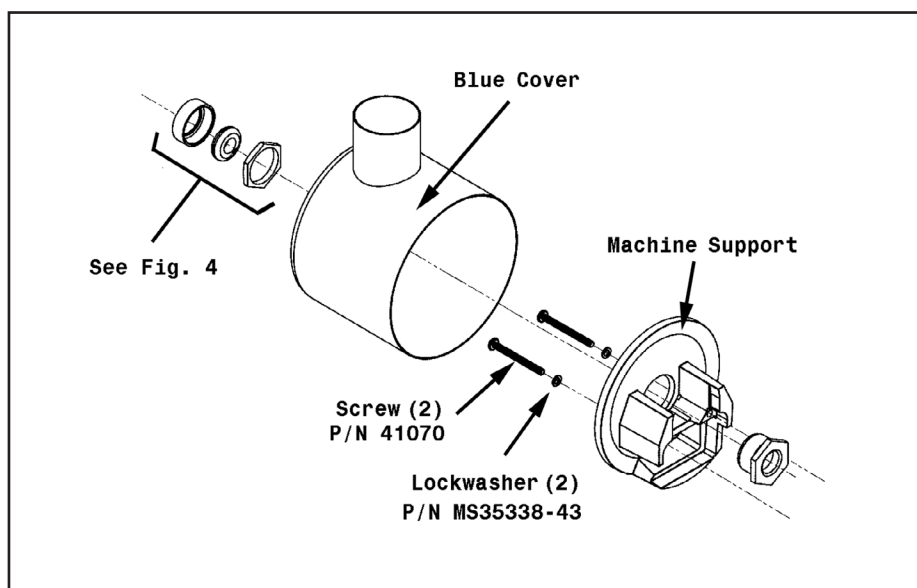
Figure 5 - Machine Support Removal

- (a) Thread the green AUX wire through the conduit connector and connect it to the stud.
  - (b) If torque of the green AUX wire nut cannot be achieved, it is permissible to remove the machine support by removing the two HET P/N 41070 screws and lockwashers. Refer to Fig. 5.
